SP Controls Application Note

3M Wall Display

Revision C

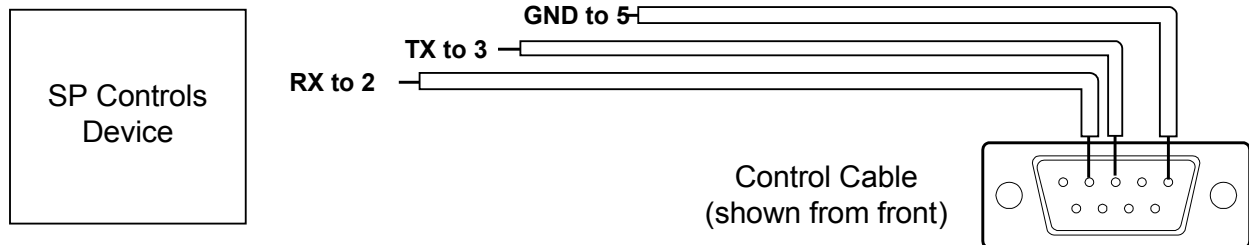
Wire RS-232 control to a male DB9 as follows:

Connect female DB9 to projector port labeled *SERIAL*.
Serial Adapters (for NRC only): Converter A and B
